# LEVEL 2 REPLACEMENT RESERVE REPORT FY 2025 TANTERRA HOA

## TANTERRA HOA

BROOKEVILLE, MARYLAND

May 01, 2025

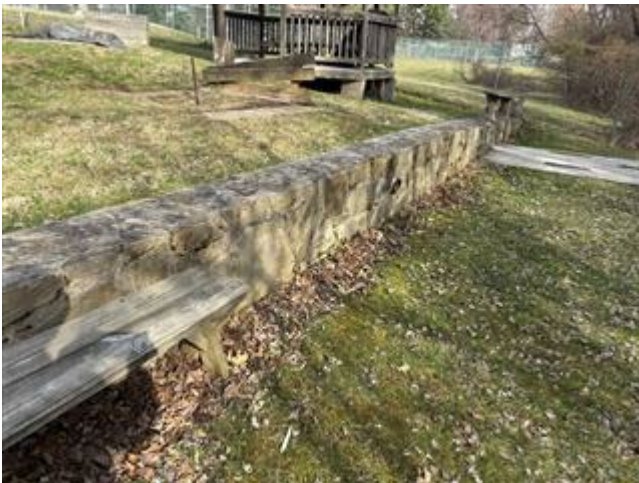
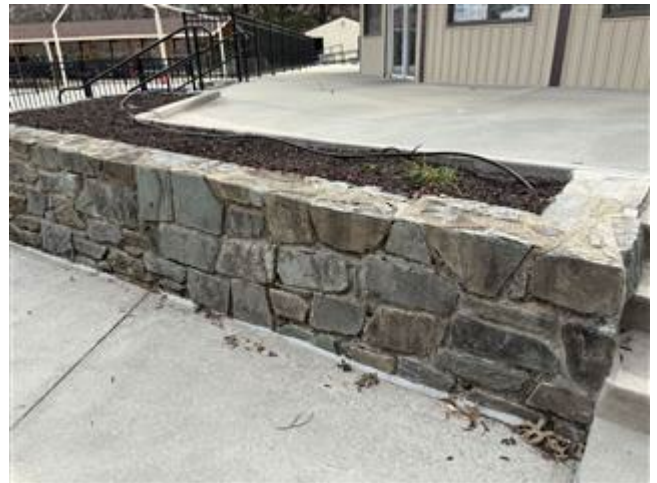
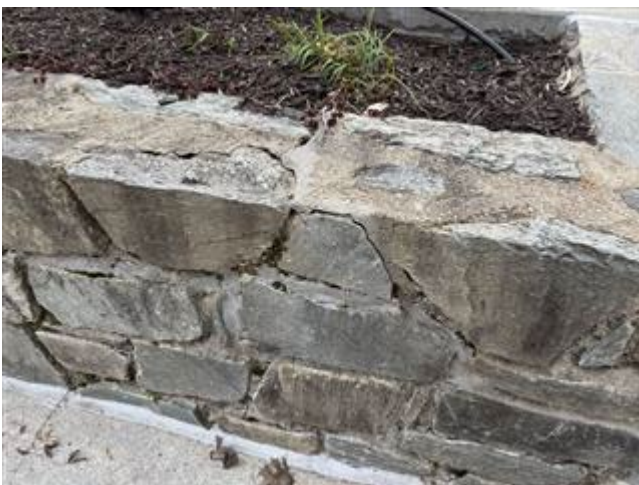
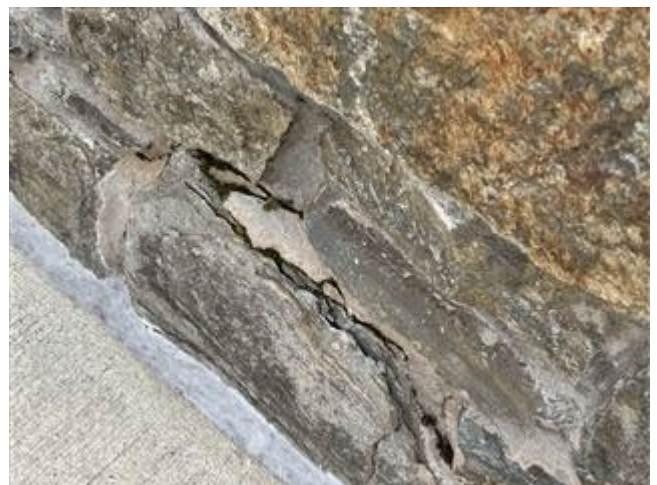
**Retaining Walls.** The Association maintains stone retaining walls within the pool area. The retaining walls are in generally good to fair condition with mortar joint deterioration and cracked stone. Retaining walls, in general, are designed to provide slope stabilization and soil retention by means of a structural system. Movement and displacement of any retaining wall is a sign of general settlement or failure. This typically is in the form of leaning and bowing and can involve the entire wall or localized sections of the wall. Typically, these types of movements are gradual and may require the replacement of the wall. Movement of retaining walls located near other buildings or structures may negatively affect the stability of the adjacent structure. These conditions can become extremely costly if not properly identified, monitored, and addressed.

Stone retaining walls can have an extended useful life of 50 years or more, and if stable, may only require periodic repointing and localized repair. Repoint is the process of raking out defective masonry joints and tooling new mortar into the joints. Properly mortared and tooled joints will repel the weather and keep water from penetrating the wall. Siloxane or other breathable sealants should be considered to provide additional protection to the wall from water penetration. This study assumes that repointing will be performed incrementally as needed to maintain the life of the wall. Retaining wall replacement can be costly, and early planning on the part of the Association can help to reduce the impact of this work on the community's budget in the future. We, therefore, recommend having a Professional Engineer inspect the walls and develop preliminary replacement alternatives and recommendations based on the site conditions, replacement costs, and recommended replacement wall types. This information can then be incorporated into future updates to the Reserve Study.

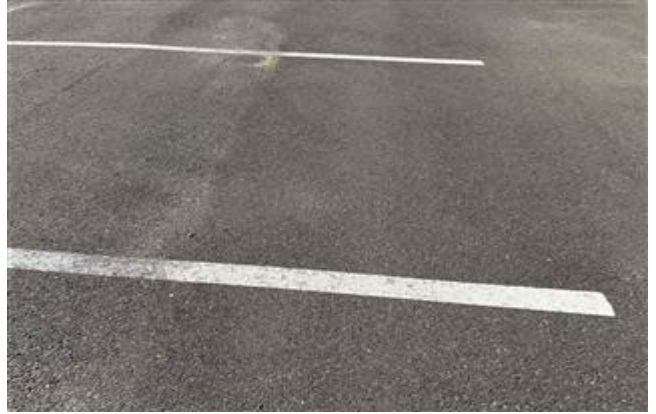
- **Seal Coating.** Pavement seal coating materials are designed to extend the life of asphalt from damage caused by UV degradation, gas/oil, road salt, and prevent water from entering into the pavement, which causes freeze/thaw cycle damage. Re-paving is very expensive, and with routine maintenance, the expense of repaving can be delayed.

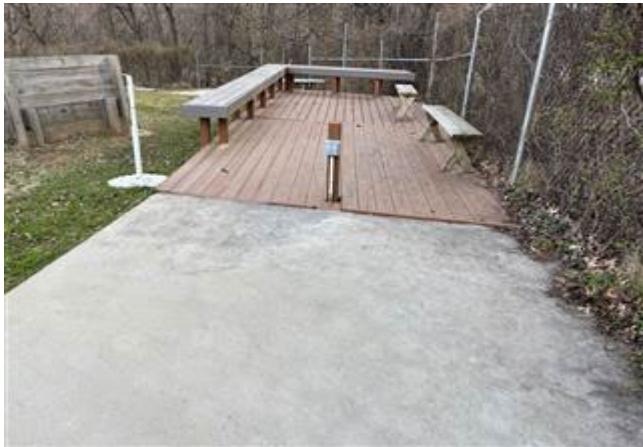
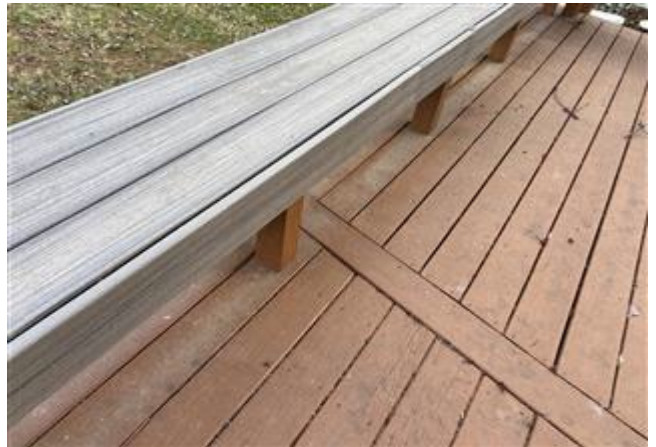
**Wood Deck and Benches.** The Association maintains a small deck and benches near the horseshoe area. The deck and benches are constructed of Pressure Treated Lumber (PLT). A portion of the decking contains horizontal surfaces. Water tends to stand on the surfaces and soak into the wood. As the sun dries and pulls the moisture out of the wood, the wood shrinks, and cracks. The wood decking material, as well as the wood benches, should be sealed every two to three years.

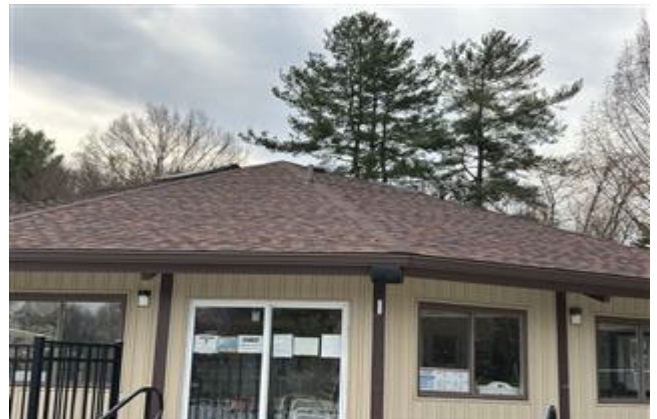
**Pool Building.** The community pool building contains two shower/restrooms, life guard rooms, and a utility room. The pool building roof consists of asphalt shingles reported to have been replaced in 2020 with 50 year warranty Certain Landmark Pro Architectural shingles. The asphalt shingles appear to be in good condition. Annual inspections are recommended, with cleaning, repair, and mitigation of vegetation performed as needed. Access, inspection, and repair work should be performed by contractors and personnel with the appropriate access equipment who are experienced in the types of roofing used for the facility.

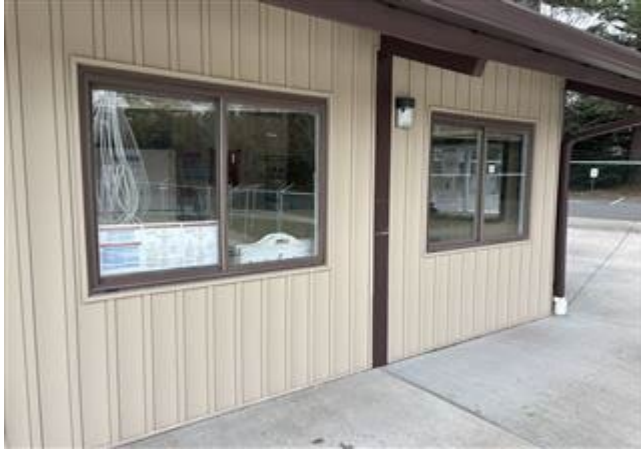
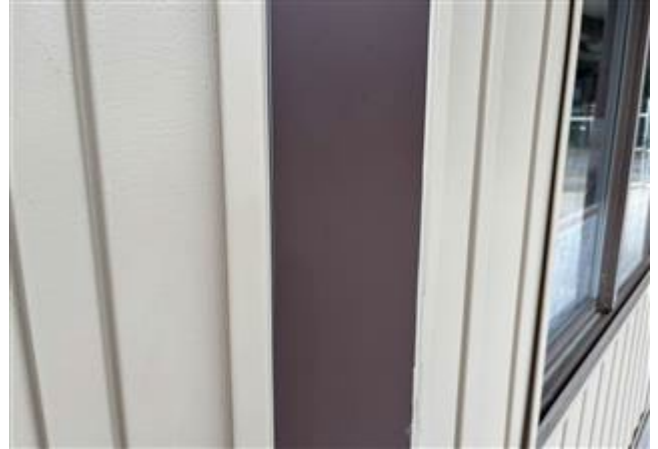
- Trim capping. Approximately 1400 square feet of aluminum capping was installed with the roof covering installation.
- Siding and Trim. The exterior of the community pool building is clad with vinyl siding and trim reported to have been installed in 2021. The siding and trim are in good condition.

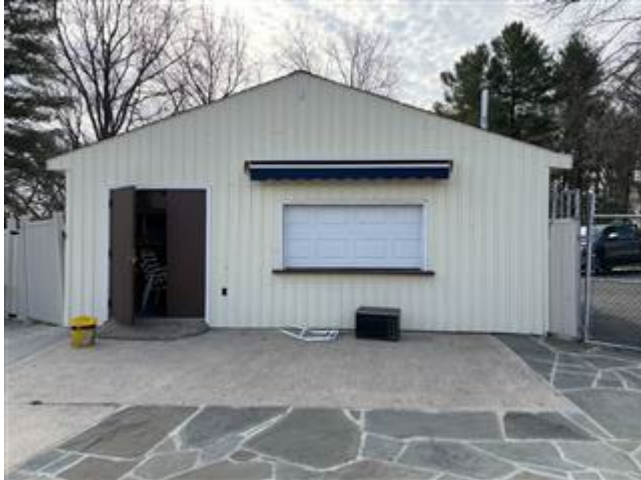
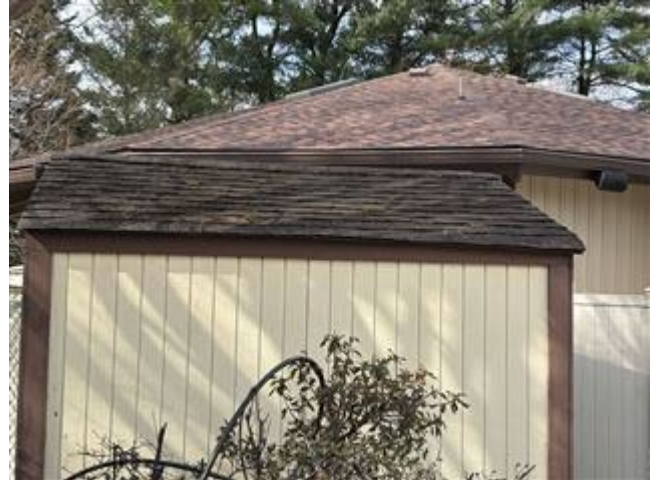
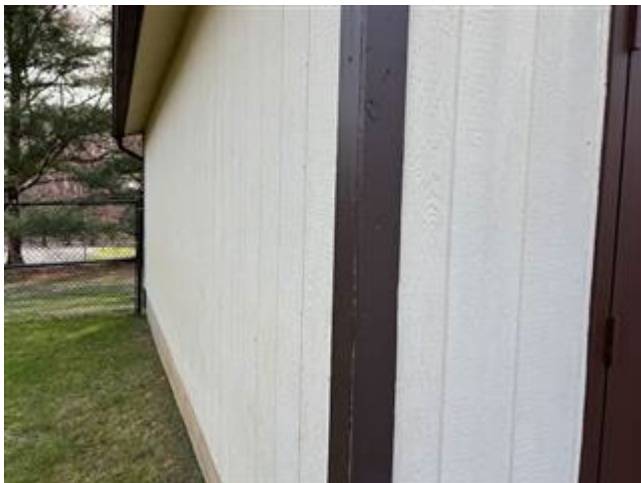
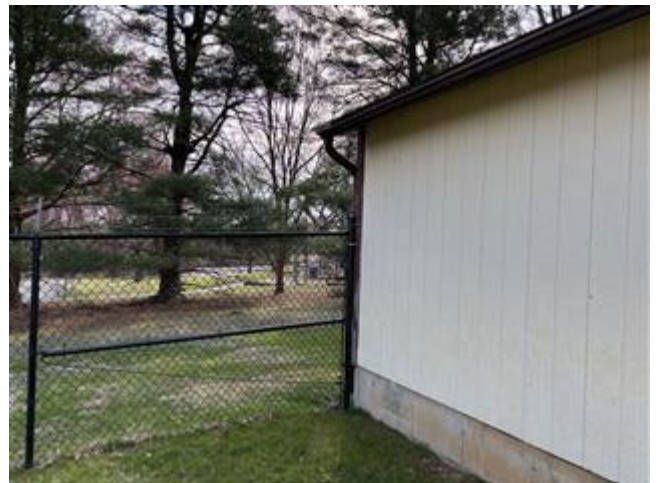
**Sheds.** The Association is responsible for three wood framed sheds that are used for a snack bar and storage purposes. Snack bar shed. The Association purchased a 24' X 26' wood framed shed in 1997. The Association installed vinyl siding on the shed in 2013. We have programmed replacement of the roof, siding, doors, service window, and awning based on the age and condition of the component. In general, the snack bar shed is in fair condition due to age related deterioration.

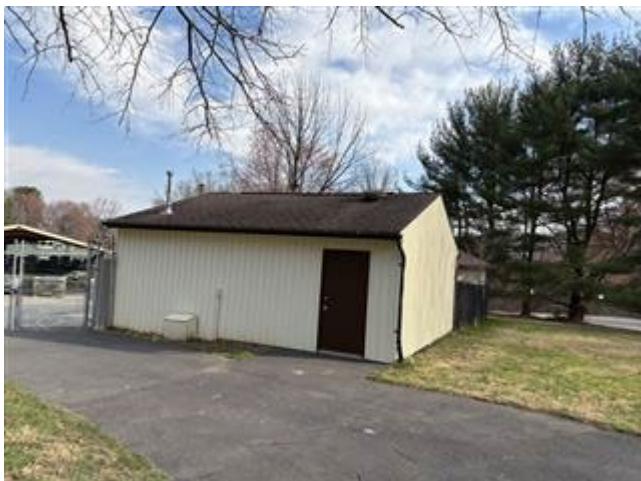
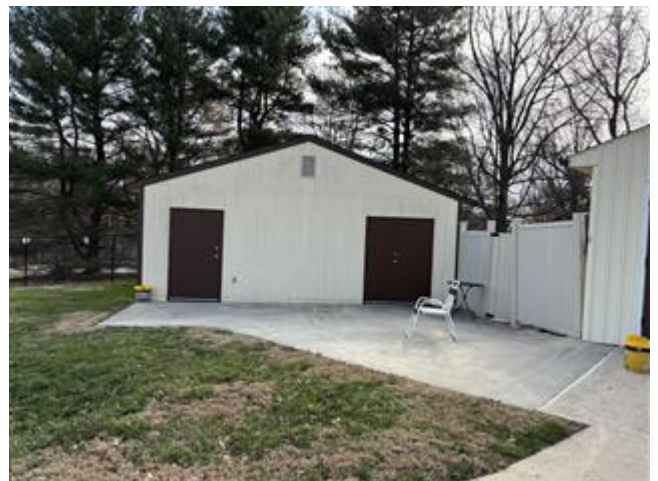
**Storage shed.** The Association purchased a 24' X 26' wood framed shed, clad with OSB T1-11 siding in 2006. The Association reported plans to install vinyl siding on the shed, when the OSB T1-11 deteriorates. We have programmed replacement of the roof, siding, and doors based on the age and condition of the component. In general, the storage shed is in fair condition with damaged siding and roof degradation.

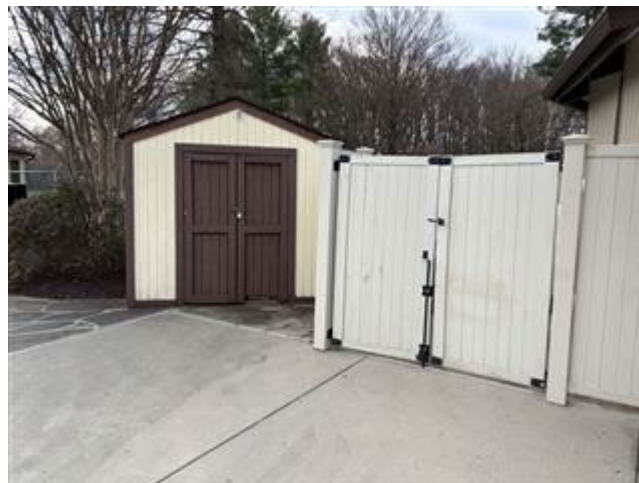
Utility Shed. The Association maintains a small 8' X 8' wood framed utility shed that is in poor condition. We have programmed replacement of the shed with a pre-cut unit. It is our understanding that volunteer labor will be utilized to assemble and install the unit.

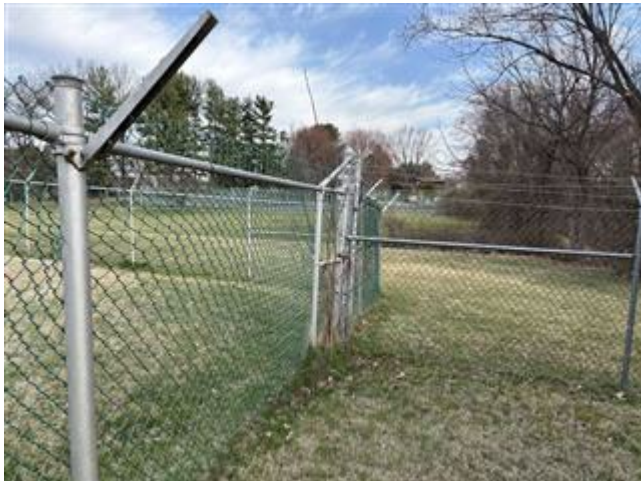
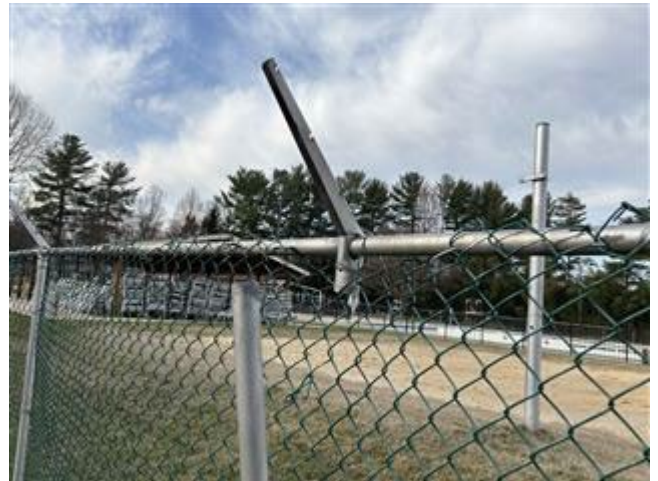
- Pool Perimeter Fence. The swimming pool area, including the Horseshoe area, is enclosed by a chain link fence. The fence fabric was replaced in 2011 and is in fair condition.

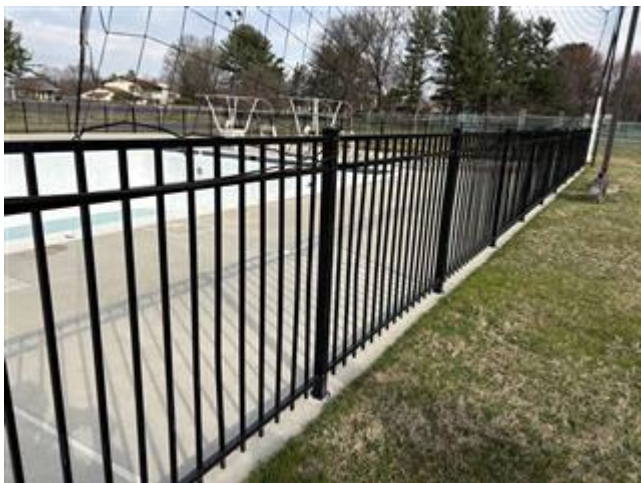
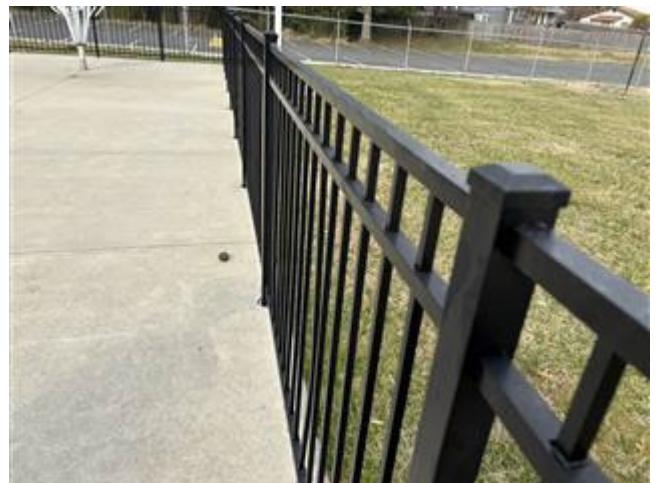
- Pool Aluminum Fence. The swimming pool and wading pools are enclosed by an aluminum fence that is in good condition.

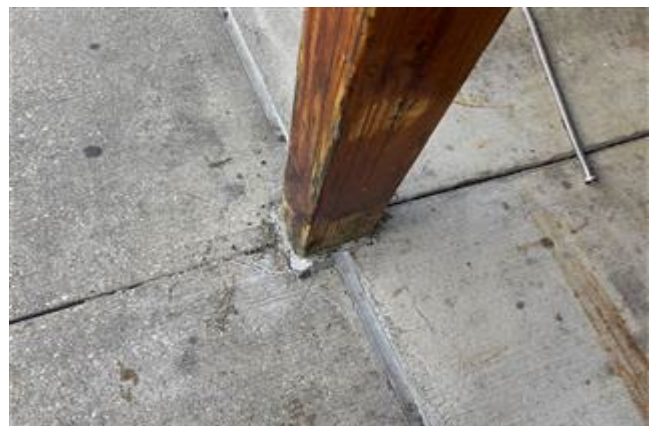
**Pavilion and Gazebo .** The Association maintains a pavilion and a gazebo of wood construction. The pavilion has an asphalt shingle roof with a concrete floor. The pavilion roof was replaced in 2019 according to the Association. The pavilion includes ceiling fans and ceiling mounted lights. The structure and roof of the pavilion appear to be in good condition with limited concrete cracks.

The gazebo has an asphalt roof with a wood floor. The gazebo appears to be in fair to poor condition with age related wear and broken boards. The rate of deterioration of the wood components of the pavilion and gazebo will vary with the level of maintenance performed on those components as well as the exposure of the pavilion and gazebo to the elements.

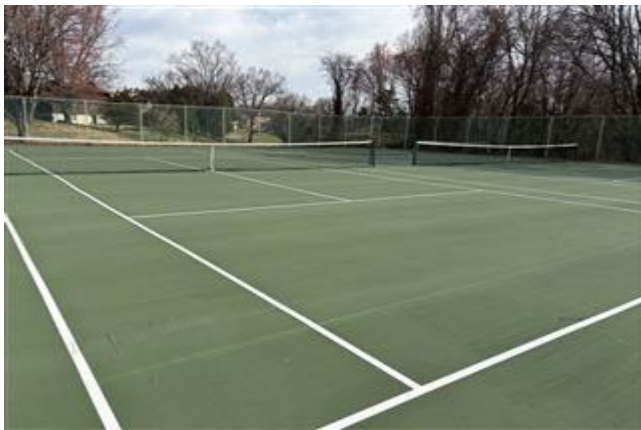
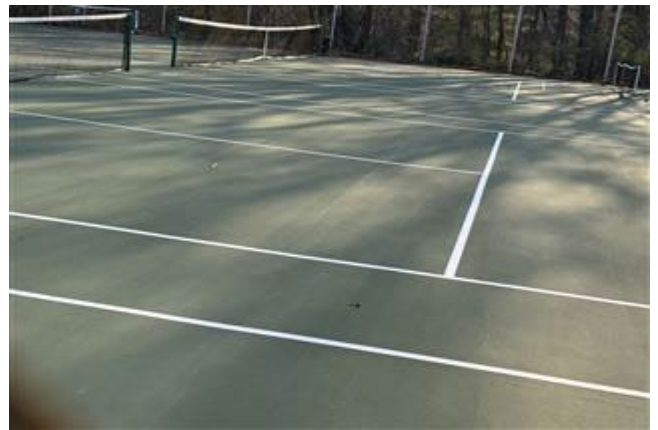
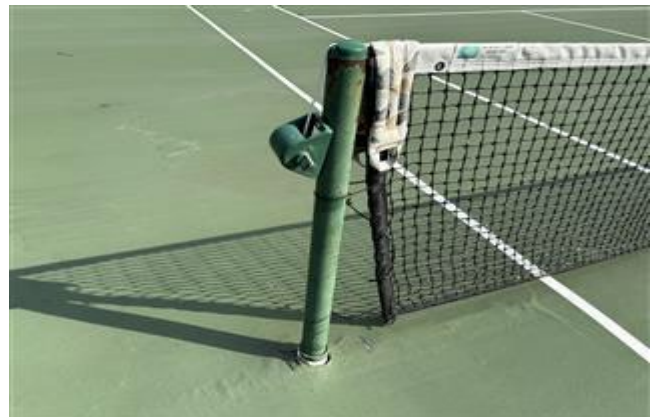
- Net Posts. We have assumed that the new posts will be replaced when the asphalt pavement is replaced.
- Tennis/Pickleball Court. The two courts are asphalt based with a chain linked perimeter fence. One court is lined for pickleball. The tennis/pickleball courts appeared to be in good condition, with some surface bubbles noted.

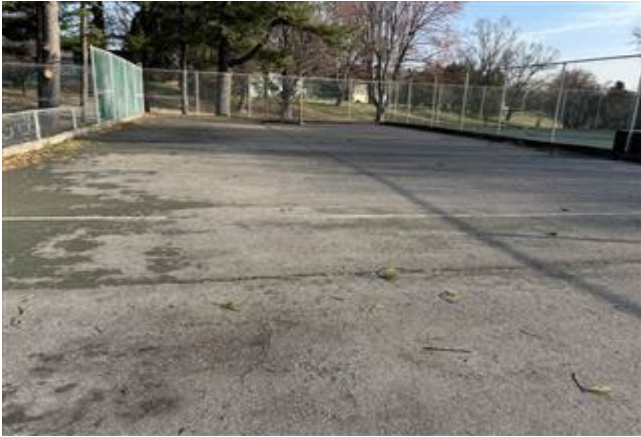
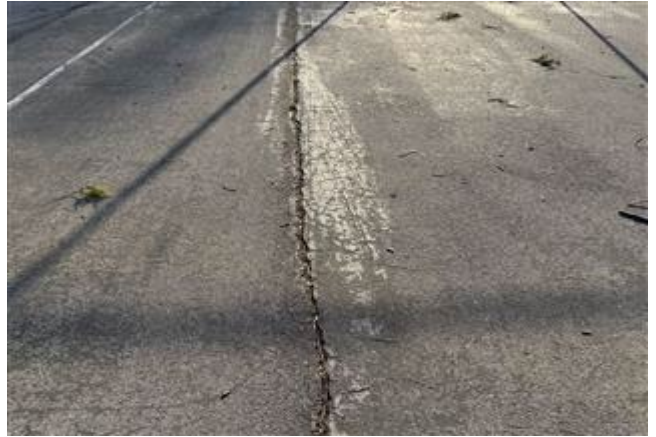
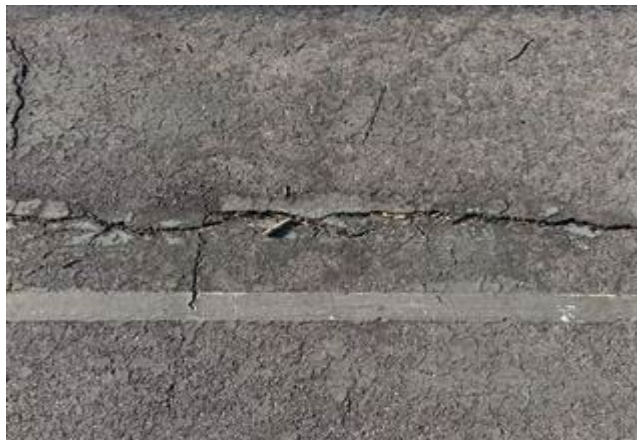
- Hockey Court. A 5,545 square foot asphalt surfaced area adjacent to the tennis court is used for roller hockey. The court surface is in poor condition with numerous open cracks.

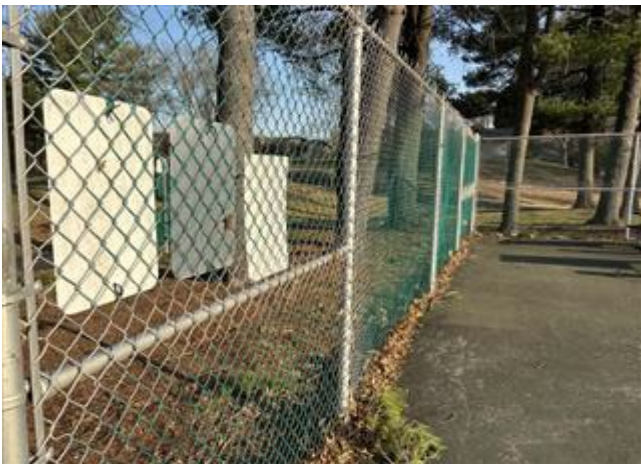
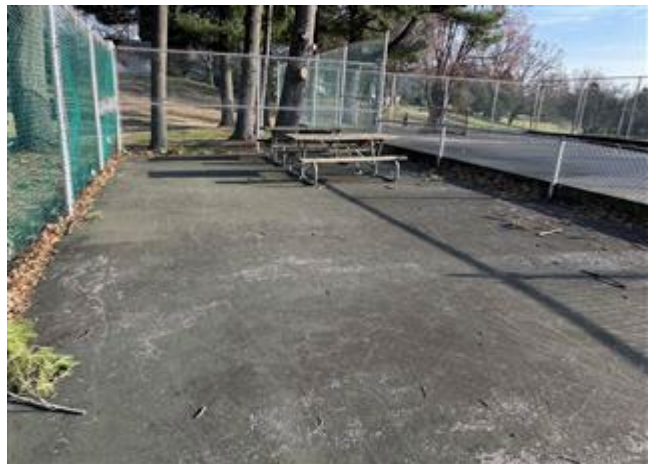
- Observation/Picnic Area. A 1,330 square feet paved area is adjacent to the roller hockey court and is used as a picnic/observation area. The area is enclosed by a chain link fence and includes several picnic tables. The surface area is in poor condition.
