# LEVEL 2 REPLACEMENT RESERVE REPORT FY 2025 TANTERRA HOA

## TANTERRA HOA

BROOKEVILLE, MARYLAND

May 01, 2025

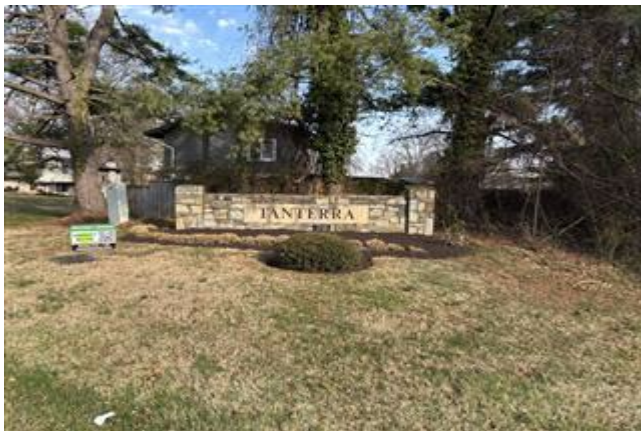
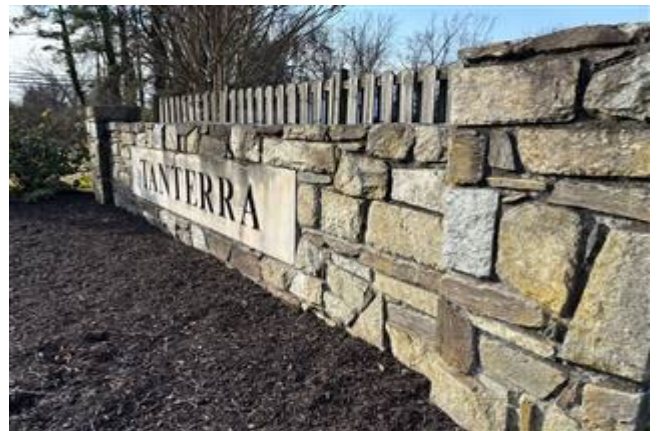
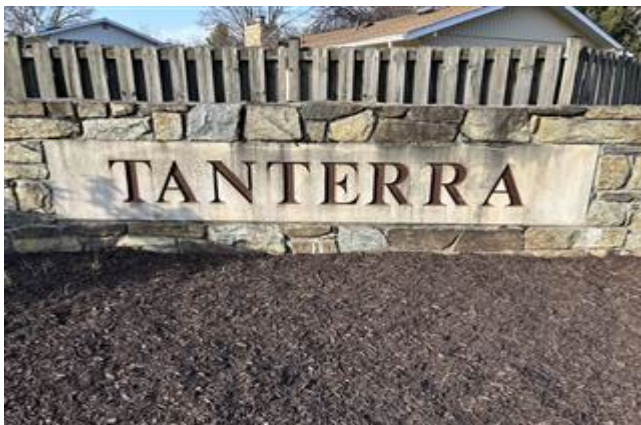
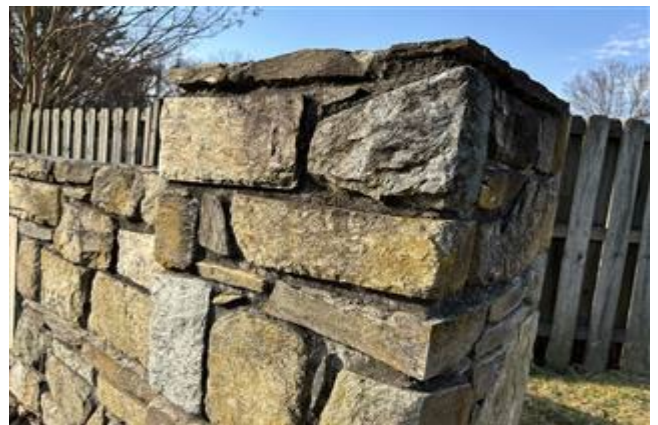
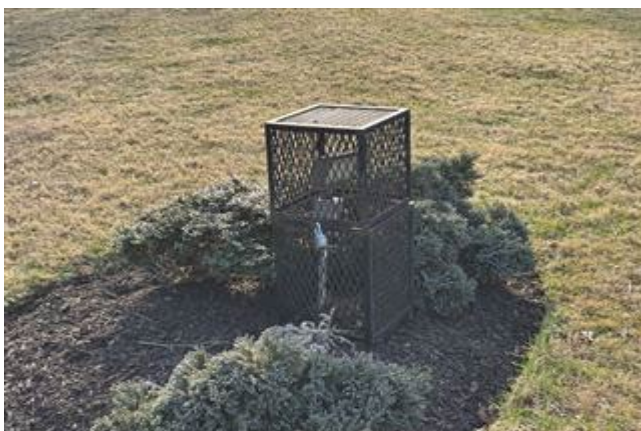
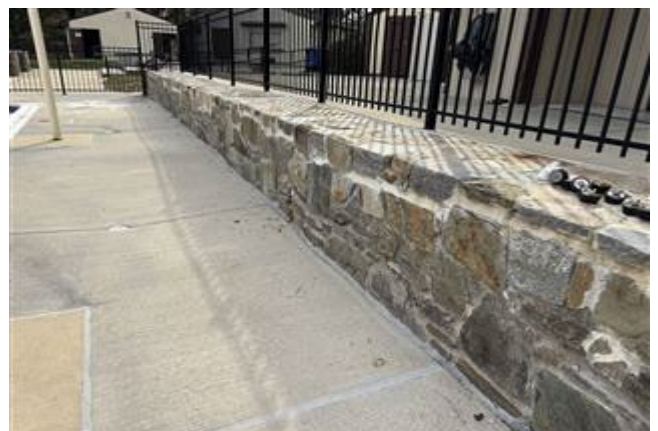
**Entry Monument and Signage.** The Association maintains two entrance monuments, located at Heritage Hills Drive and Georgia Avenue, consisting of stone masonry columns and a wall with a carved stone signage panel on the roadside face. Various other community stone walls and the stone barbecue are also included in this component. The monument and sign, as well as the other stone work, appears to be in good to fair condition with age related wear and select mortar deterioration noted.

Because the stonework has a very long life expectancy, we have excluded replacement of these walls. However, we recommend re-pointing, as needed, and have included funding for the periodic re-pointing of mortar joints, as exposure to weather over an extended period of time will wash lime out of the mortar and weaken the joint. Periodic re-pointing of these joints and replacement of damaged stone is required to extend the life of the wall. The Association may want to consider applying a coating of Siloxane or other appropriate breathable sealants to mitigate water penetration and further degradation of the masonry work. The monuments and signs are lit by ground mounted lights. Other small miscellaneous signs are not considered in this study and should be replaced using other funds.

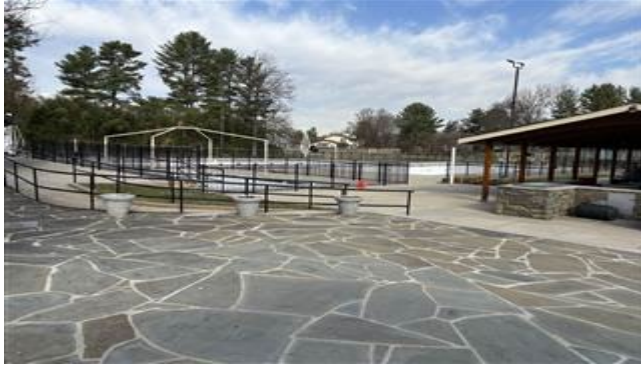
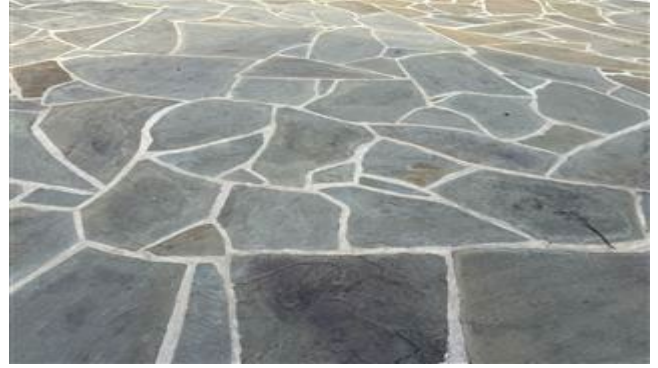
**Flagstone Pavers.** Flagstone pavers provide a solid, decorative, and renewable surface that is part of the community pool area. The overall condition of the mortar grouted brick pavers is good to fair with age-related wear, which includes select cracking and settlement. The Association reports that the stone decking pavers were re-grouted in 2022. Defects may include the following:

To correct defects and provide the longest service life of the mortar grouted flagstone paver system, periodic resetting of the pavers is required. Re-setting provides an opportunity to replace broken unit pavers, fill in voids in the foundation material, level the surface, and replace the grout. We have included an allowance for periodic resetting and re-grouting of those portions of the system. Flagstone pavers have a long service life of 30 years or more, provided they are periodically maintained. Eventually, pavers will require large-scale replacement, particularly when identical paver units are no longer available.

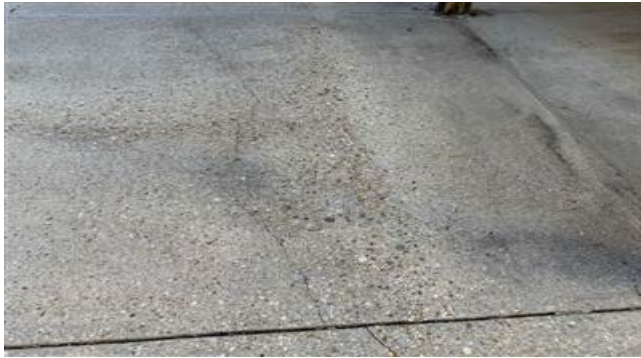
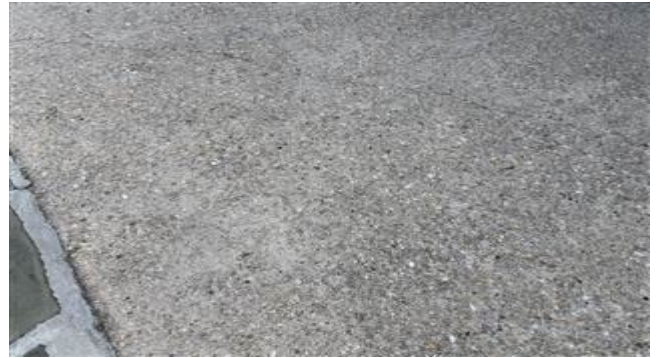
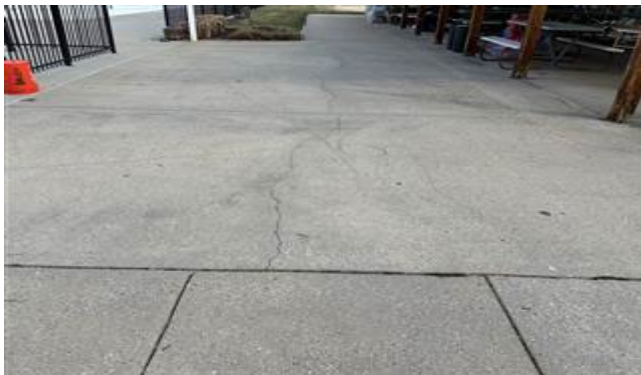
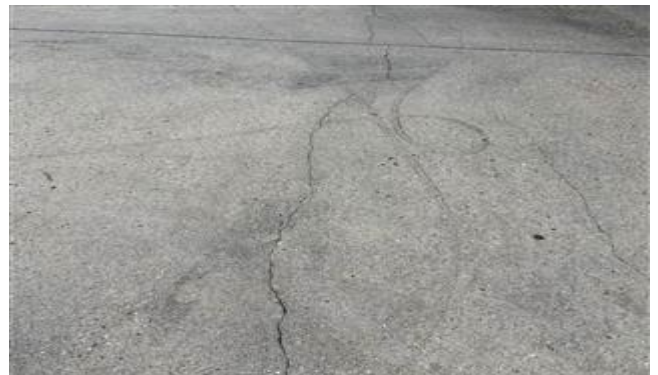
The concrete flatwork includes the community concrete flatwork at the community pool building, pavilion, horseshoe area, snack bar, and storage shed areas, steps, barrier curbs, monolithic curb, and sidewalks. It was noted that the concrete flatwork was replaced in 2013 along with the major renovation of the swimming pools. Generally, the concrete flatwork appears to be in good to fair condition with open cracks and spalling in select areas.

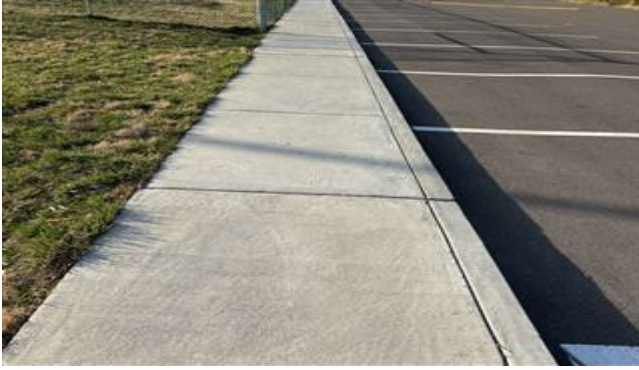
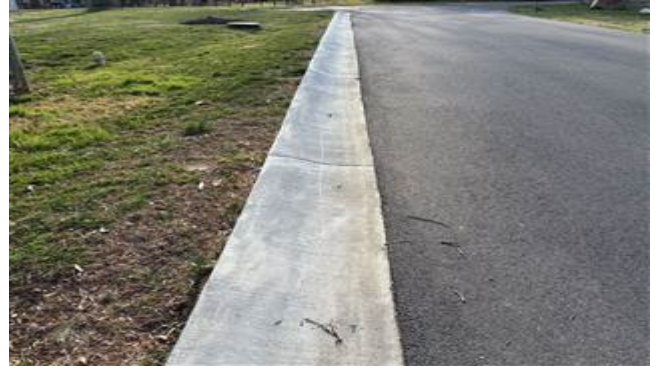
The curb and sidewalk along the east side of the parking area are monolithic units and are in good condition.

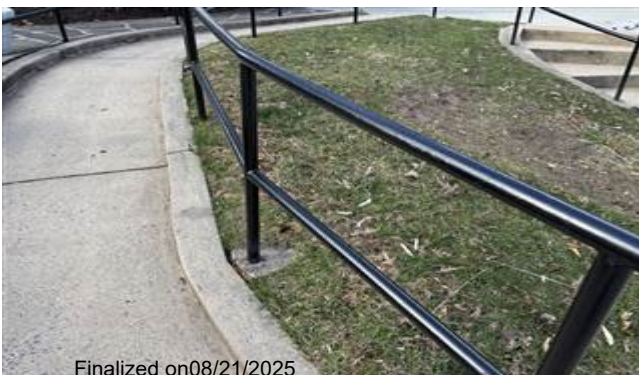
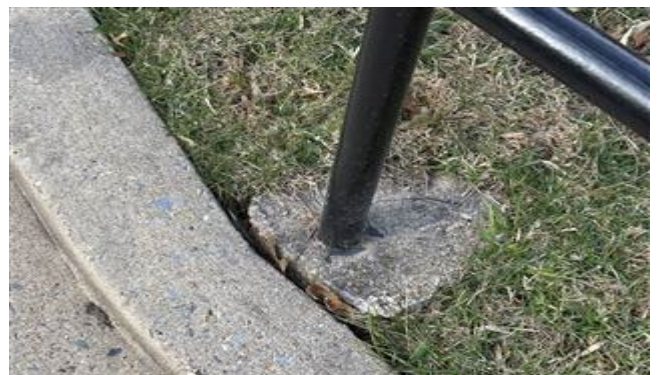
**Metal Hand Railing.** The Association maintains metal piping handrails and railing posts that are embedded in concrete at the pool area. The railing is in good condition. With a program of periodic painting, the railing has an indefinite life expectancy. If left unattended, the pressure from expansive post rust can crack and damage the supporting material. As part of normal maintenance, we recommend the following:

- Remove the existing sealant completely.
- Clean, prime, and paint all posts, rails, and pickets.
- Apply an appropriate sealant around each post base.
- Tool and shape sealant to shed water from the post.

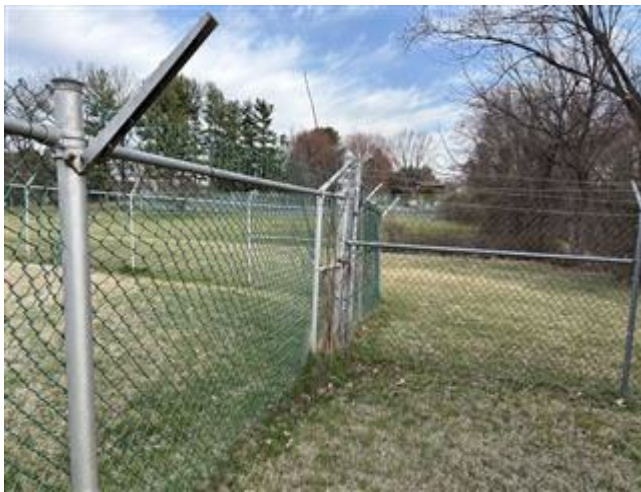
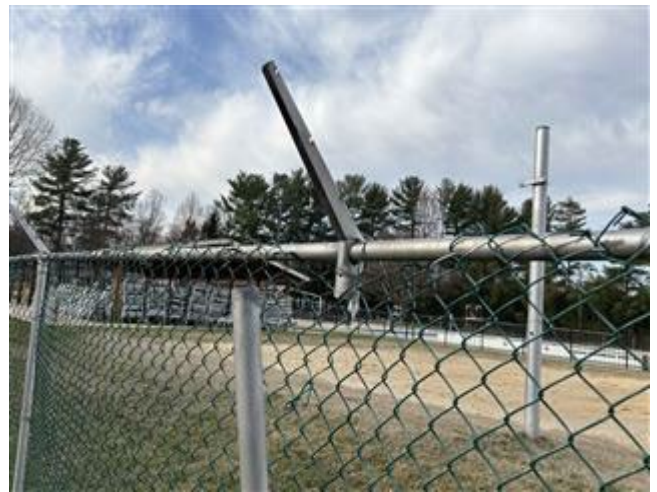
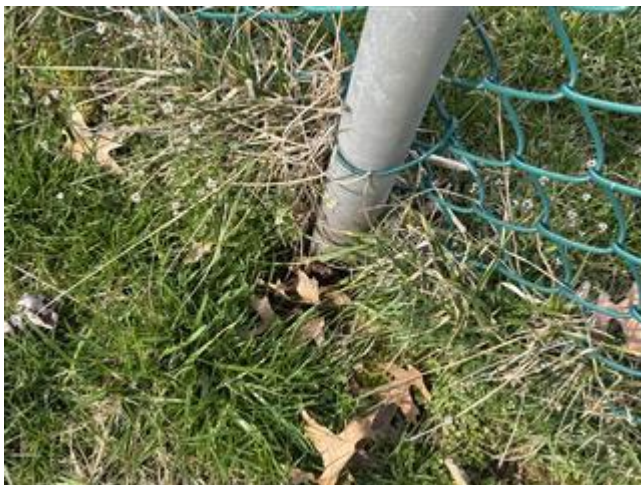
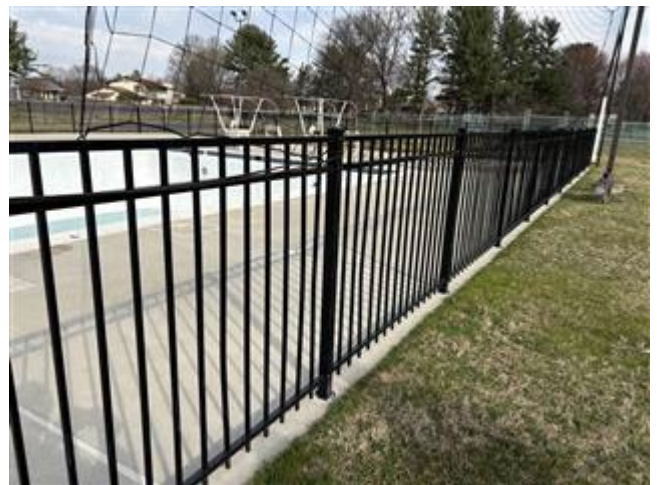
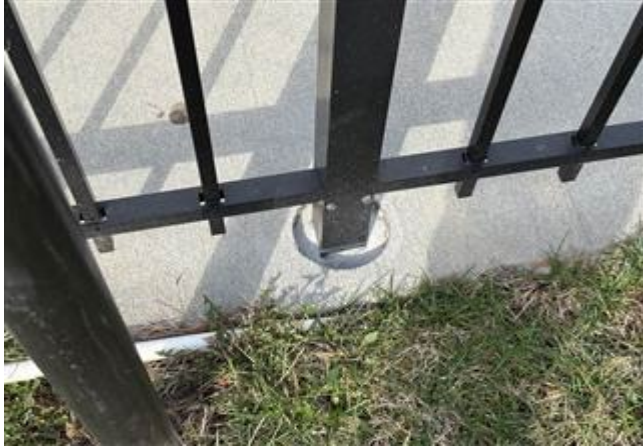
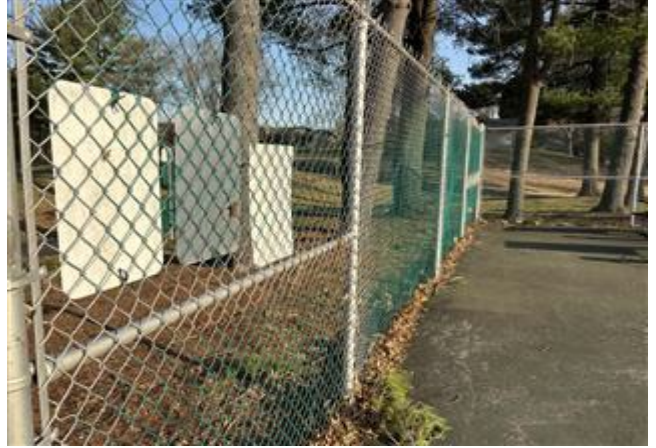
**Chain Link Fencing.** The Association maintains galvanized chain link fencing that surrounds the pool area and encloses the two pools, picnic area, pool building, and various sheds. The fencing appears to be in good to fair condition, with some leaning posts and fence sections. Fencing systems have a large number of configurations and finishes that can usually be repaired as a maintenance activity by replacing individual components as they become damaged or weathered. Protection from weed trimmer string during lawn maintenance can extend the useful life of some fence types. Protection from this type of damage is typically provided by applying herbicides around post bases or installing protective sheathing. Chain link fencing can have a useful life of 40 years or more. Periodic repair or replacement of posts or top rails may be required as regular maintenance.

- Lift or remove ornamental base covers, if applicable.
- Remove the existing caulk completely.
- Clean, prime, and paint all posts.
- Apply an appropriate caulk around each post base.
- Tool and shape caulking to shed water from the post.
- Reinstall base covers, seal and paint all joints.

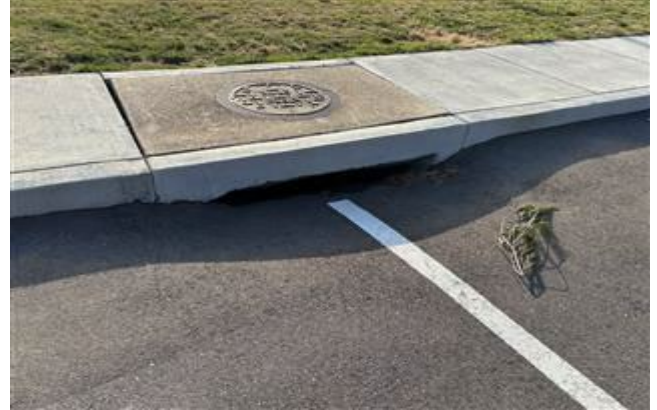
**Stormwater Management.** The stormwater management system consists of curbs and storm drains. Stormwater runs from the curbs or catch basins into the storm drains. Water then drains into various detention basins or retention ponds surrounding the community or community storm systems. The system appears to be in good condition. The community should maintain the stormwater management system to function as designed, limit erosion, and channel water to the appropriate drainage outlets. No engineering drawings or stormwater management plans were available to accurately determine water flow from the roadway to the adjacent waterways. Accordingly, we have provided an estimate of the approximate replacement or refreshment cost based on our experience with other communities of similar size and our inspection of the visible components while on site. Inspection of the underground lines and structures is beyond the scope of work for this study.

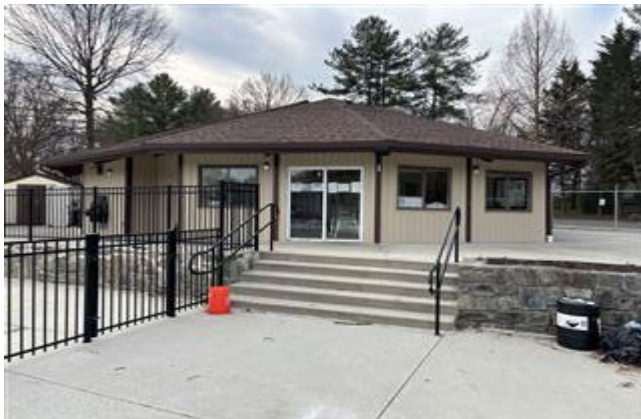
**Pool Building.** The community pool building contains two shower/restrooms, life guard rooms, and a utility room. The pool building roof consists of asphalt shingles reported to have been replaced in 2020 with 50 year warranty Certain Landmark Pro Architectural shingles. The asphalt shingles appear to be in good condition. Annual inspections are recommended, with cleaning, repair, and mitigation of vegetation performed as needed. Access, inspection, and repair work should be performed by contractors and personnel with the appropriate access equipment who are experienced in the types of roofing used for the facility.

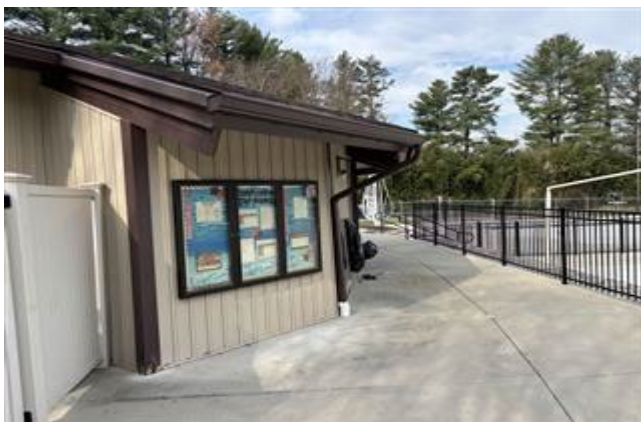
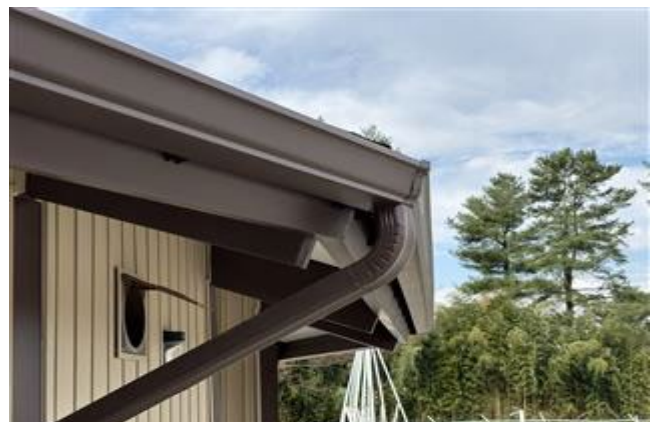
**Skylights.** Four Velux CO6 fixed deck mounted skylights with new flashing were installed as part of the roof covering installation.

- **Gutter and Downspouts.** 187 lf. of 6 aluminum gutters and 130 lf. of downspouts were installed as part of the roof covering replacement.

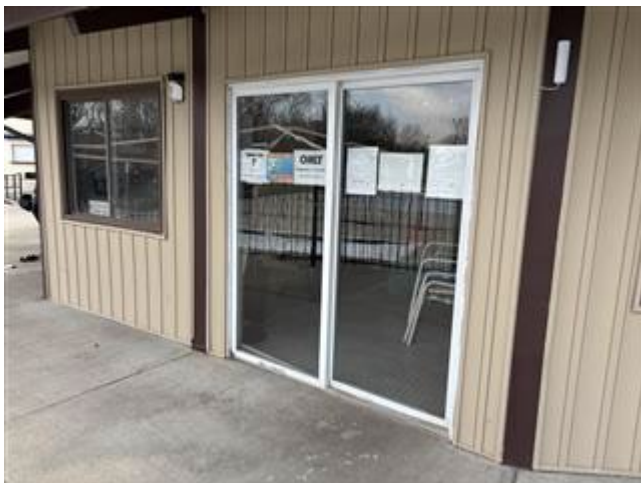
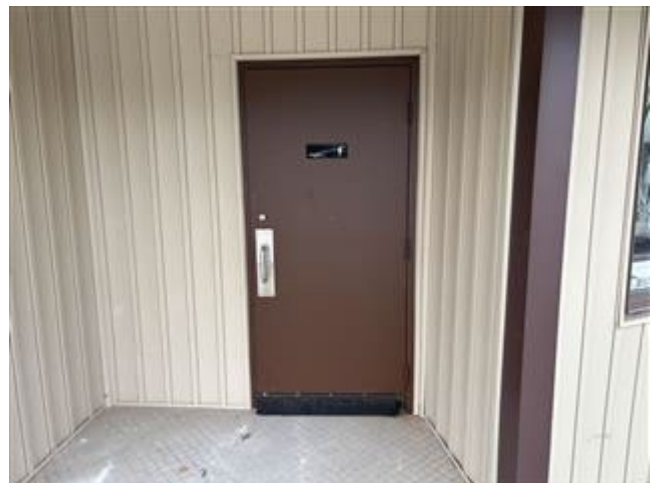
- Trim capping. Approximately 1400 square feet of aluminum capping was installed with the roof covering installation.
- Siding and Trim. The exterior of the community pool building is clad with vinyl siding and trim reported to have been installed in 2021. The siding and trim are in good condition.

- Soffits. The existing soffits are exposed to T&G roof sheathing. Vinyl soffit material was reportedly installed in 2021. The soffits are in good condition.

- Windows. The building has four aluminum windows, located in the lifeguard room. In general, we recommend coordinating the replacement of these units with other exterior work, such as siding and roof replacements. The weather tightness of the building envelope often requires transitional flashing and caulking that should be performed in coordination with each other. Warranties and advantages in 'economy of scale' can often result in lower overall replacement costs and results that are more reliable. Lastly, coordinated replacements offer the opportunity to correct initial construction defects and improve the effectiveness of details with improved construction techniques and materials.

- Doors. The building contains 5 metal exterior doors and frames and one sliding glass door unit. The metal doors and frames are generally in good to fair condition.

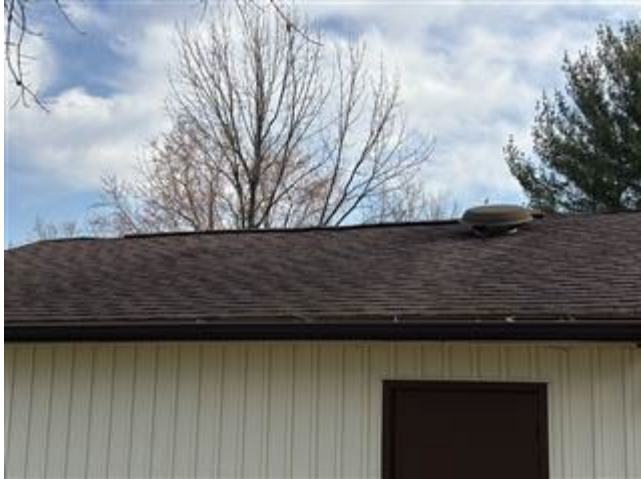
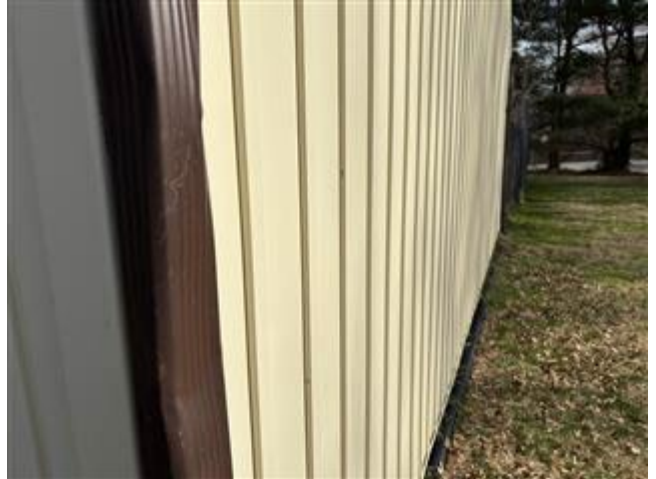
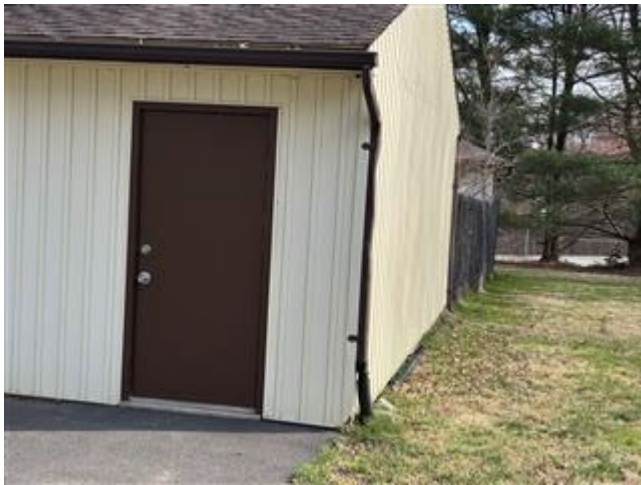
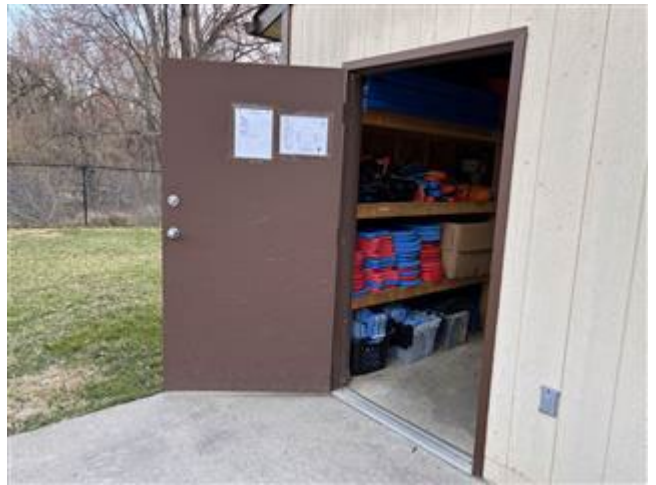
**Storage shed.** The Association purchased a 24' X 26' wood framed shed, clad with OSB T1-11 siding in 2006. The Association reported plans to install vinyl siding on the shed, when the OSB T1-11 deteriorates. We have programmed replacement of the roof, siding, and doors based on the age and condition of the component. In general, the storage shed is in fair condition with damaged siding and roof degradation.

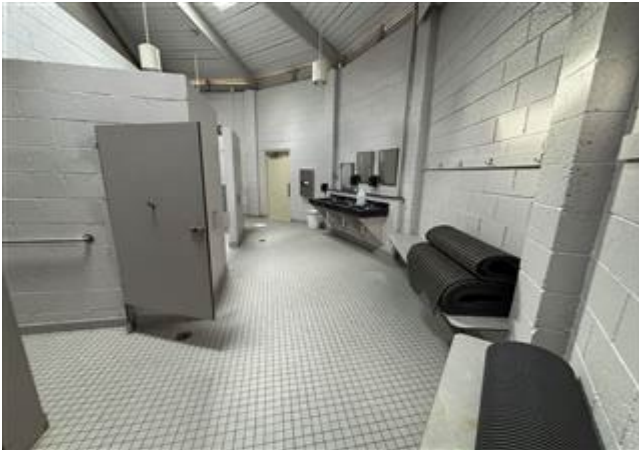
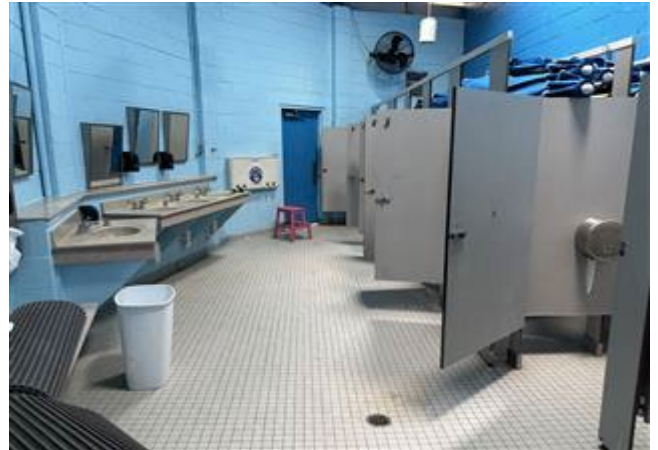
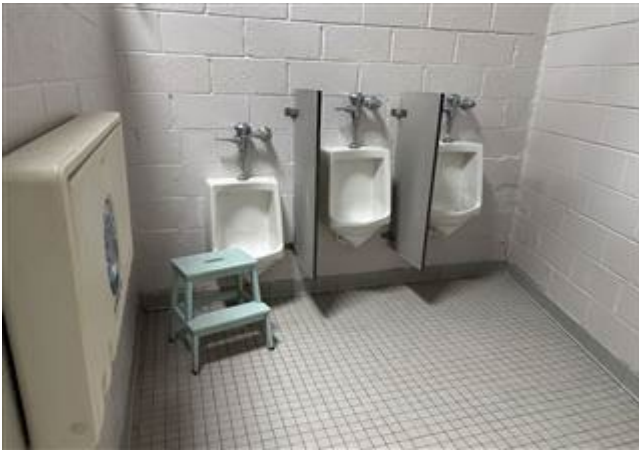
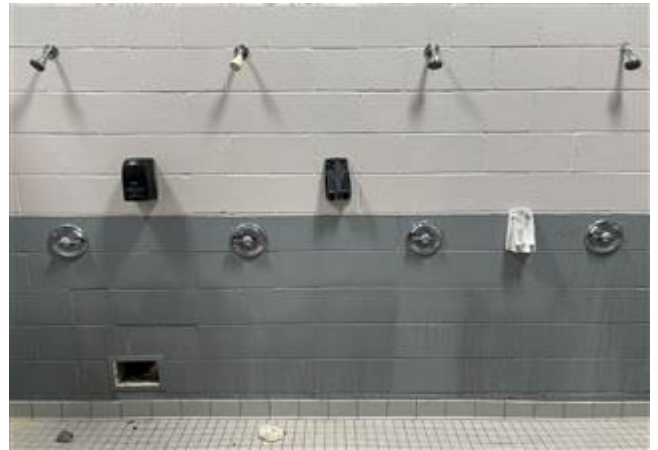
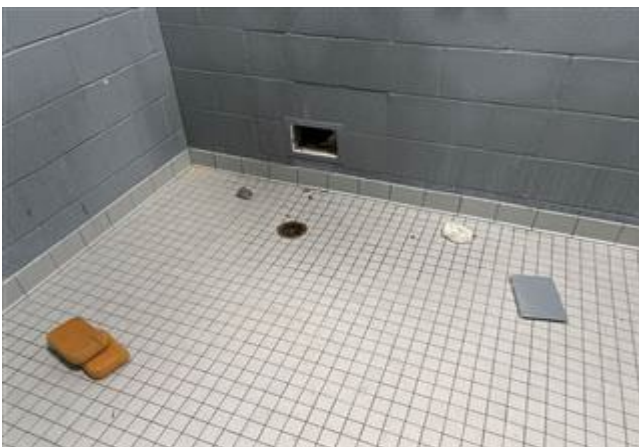
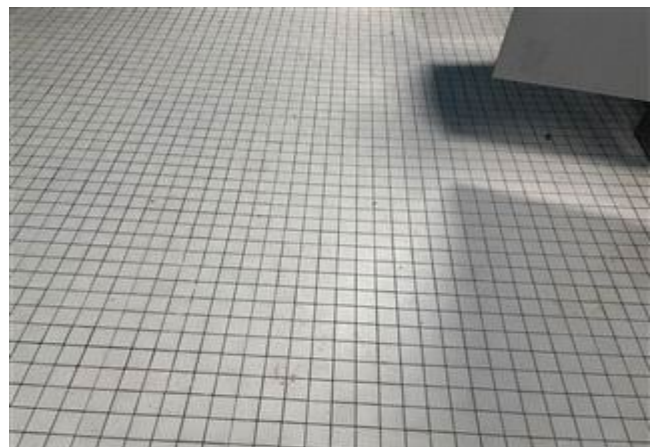
- Ceramic Floor Tile. The ceramic tile in the two restrooms/shower rooms and lifeguard room is in fair condition.
- Ceiling. The ceilings of the locker rooms and lifeguard rooms appear to be in fair condition.

- Walls. The walls in both restroom/shower rooms are painted concrete masonry block (CMU) and are in good to fair condition.
- Light Fixtures. Illumination is provided by ceiling-mounted pendant light fixtures. The fixtures are in good working condition and provide adequate lighting. Fixtures of this type have a typical service life of 25 years.

- Shower and Restroom Fixtures. All shower and restroom fixtures are in good to fair condition. We have assumed a service life of 20 years for the fixtures and that all fixtures will be replaced at the same time as part of a general renovation of the restroom.

- Lifeguard Room. The interior walls are covered with painted siding. We have provided funding to renovate the room. We have reserved for the defibrillator, computer, and PA system separately. The Association reports that the furnishings will be replaced with Operating Budget funds.

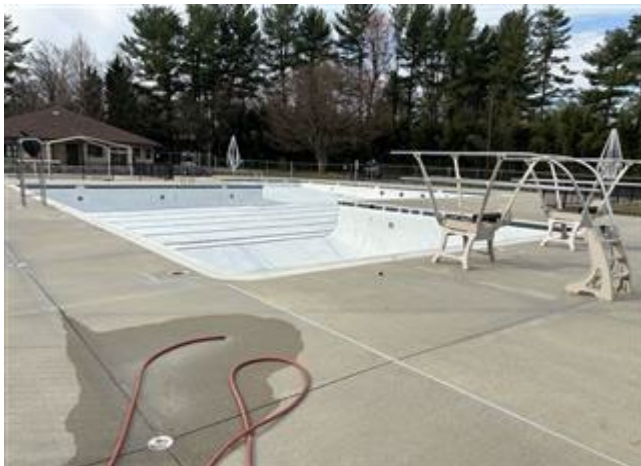
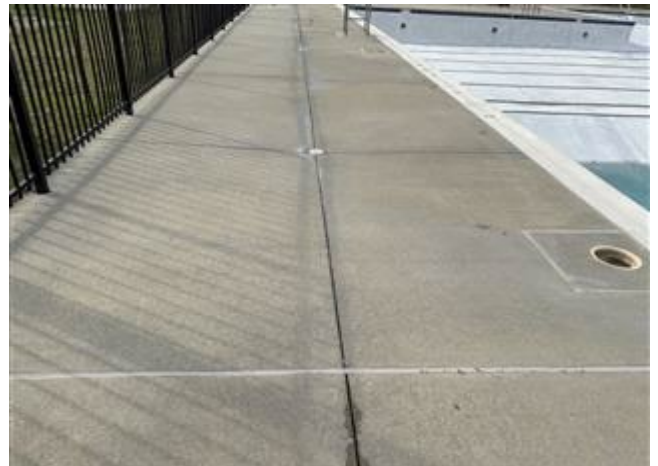
- **Pool Shell.** The shell for the swimming pool and wading pool was replaced in 2013 and is in good condition.
- **Pool Deck.** The pool has a concrete deck. The overall condition of the deck is good to fair condition with limited cracks noted.

- **Whitecoat.** The pool whitecoat was replaced with a Diamond Brite finish in late 2020. The white coat is in good condition.
- **Waterline Tile.** The waterline tile was refurbished as part of the white coating installation. The waterline tile is in good condition.

- **Coping.** The pool and wading pool is edged with precast concrete coping. The coping is in good condition.
- **Dive Stands and Boards.** The dive stands were refurbished in 2024 and the dive boards were refurbished in 2023 and 2024 respectively.

- **Pool Filter System.** The pool commercial sand filter system was replaced in 2011 and is in good operating condition. We have assumed a service life of 30 years for the filter system, based on Association changing the sand and gravel media periodically.

- **Pool Pump System.** The pool pump system was reported to be in good operating condition. The Association has a spare pump motor to be installed in the system in the event of a pump failure.

- **Wading Pool Filter System.** The wading pool sand filter is in good operating condition.
- **Wading Pool Pump System.** The pump system was reported to be in good operating condition.

- **Chlorination tanks and pumps.** The chlorination system consists of two plastic tanks and two programmable pumps.

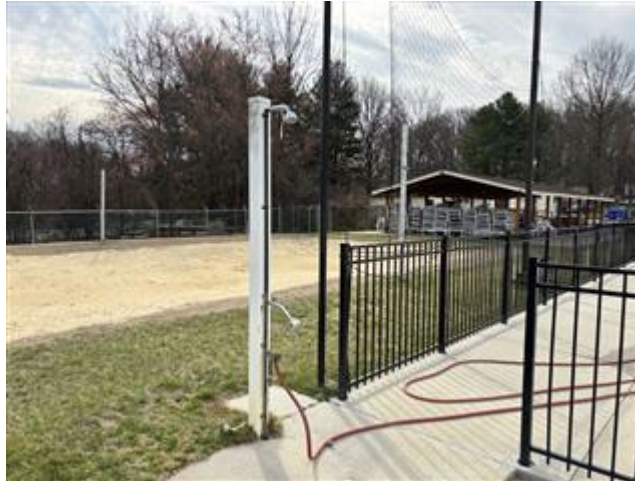
- Exterior shower stations. There are four exterior shower stations located around the pool. The exterior shows appear to be in good condition but they were not operational during the winter months.

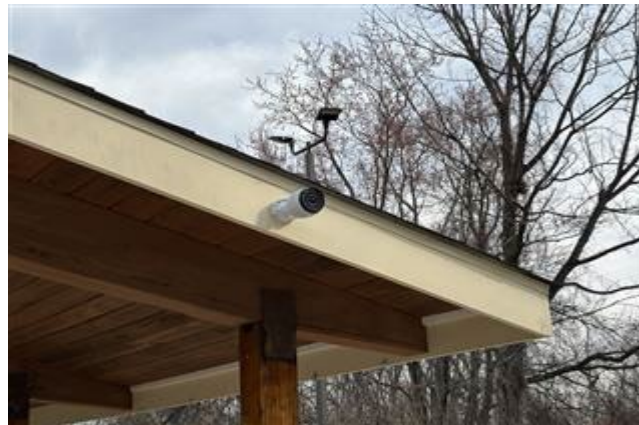
**Pavilion and Gazebo .** The Association maintains a pavilion and a gazebo of wood construction. The pavilion has an asphalt shingle roof with a concrete floor. The pavilion roof was replaced in 2019 according to the Association. The pavilion includes ceiling fans and ceiling mounted lights. The structure and roof of the pavilion appear to be in good condition with limited concrete cracks.

The gazebo has an asphalt roof with a wood floor. The gazebo appears to be in fair to poor condition with age related wear and broken boards. The rate of deterioration of the wood components of the pavilion and gazebo will vary with the level of maintenance performed on those components as well as the exposure of the pavilion and gazebo to the elements.
